Kawartha Lake Stewards Association

2018 Annual Lake Water Quality Report

Our Kawartha Lakes: Past, Present and Future

MAY 2019

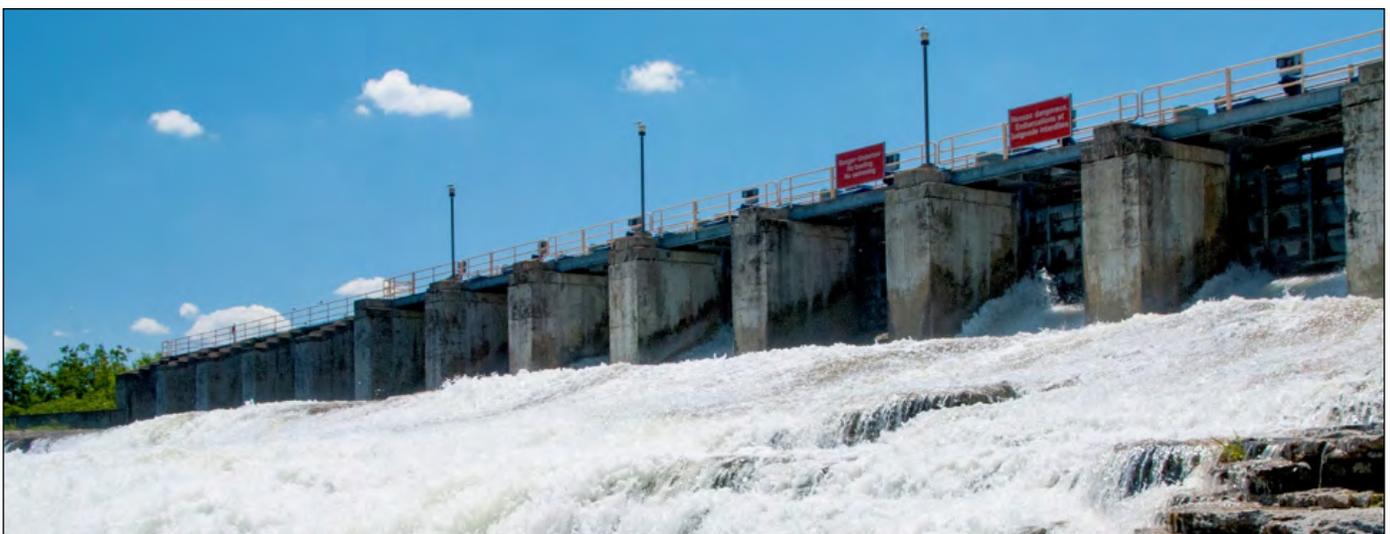
Lock 15 Healey Falls, approximately 11 km upstream of Campbellford, ON

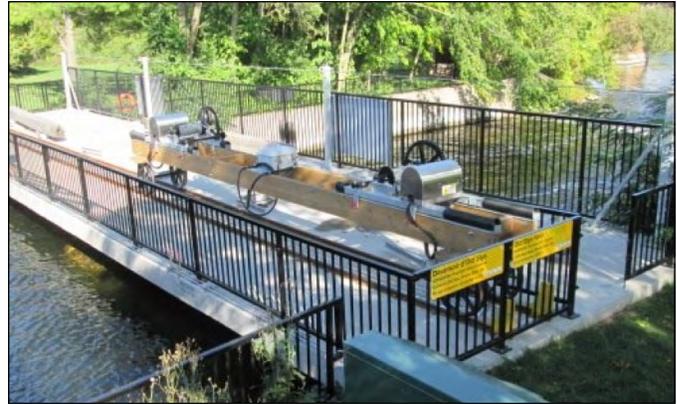
Old Slys Waste Weir - Smiths Falls, ON

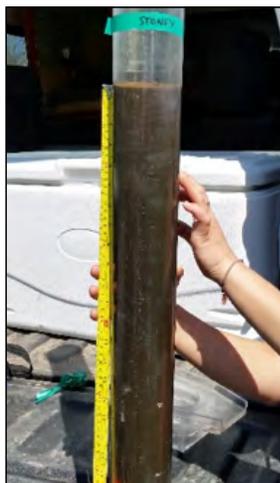
Sediment core from Stony Lake

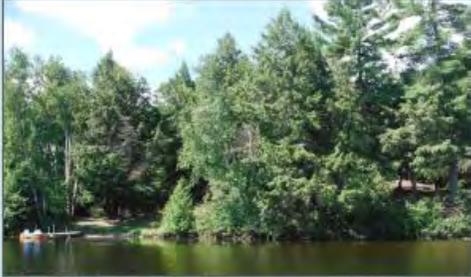
Classification & Description	Photograph Example*
<p>Natural – A healthy buffer of vegetation and/or a natural shoreline of sand or exposed rock that is undisturbed and undeveloped.</p>

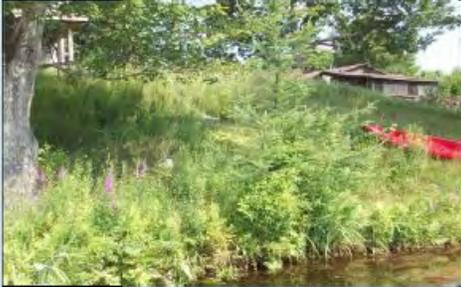
<p>Regenerative – Natural vegetation has been removed in the past, but is in the process of growing back towards a natural state.</p>

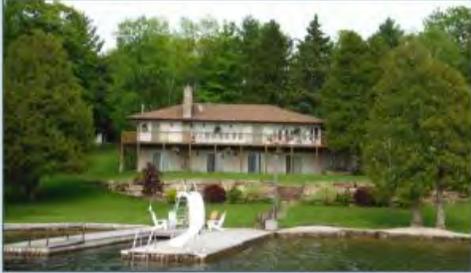
<p>Ornamental – All natural vegetation has been removed and replaced with mowed lawn and other non-native vegetation; structures such as docks, decks, boathouses and boat ramps are predominantly present at the shore.</p>

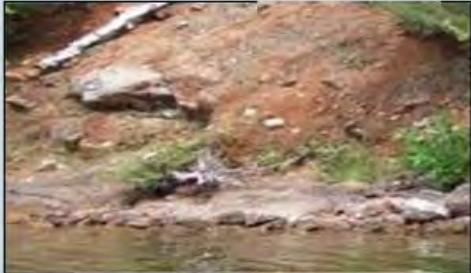
<p>Degraded – Natural vegetation has been lost; soil erosion, undercutting of the bank and/or exposed roots of shrubs and trees are significant.</p>

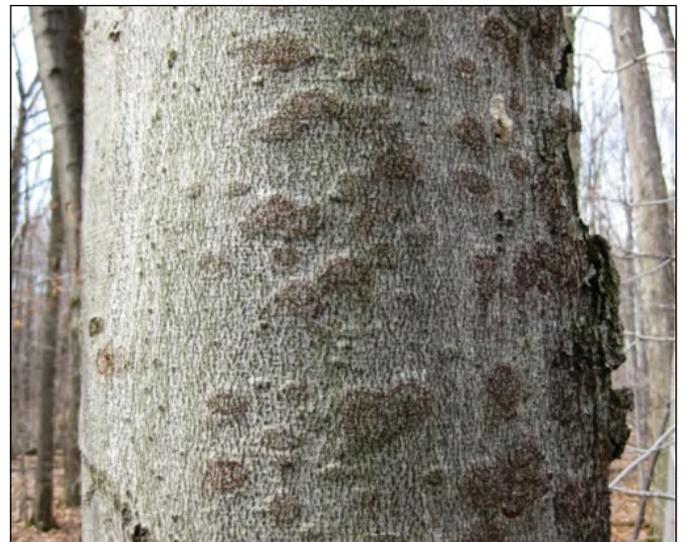
Trunk of diseased tree

The disease has two stages – first the tree is infested by invasive scale insects, introduced from Europe, which are moved by wind, animals or by the movement of infected wood. These scale insects feed on the beech tree sap by creating tiny openings in the bark. The tiny openings then allow for the second stage of the disease, the colonization of a nectria fungus, which is thought to be native in North America and spread by wind and rain splash. This fungus causes cankers to form which cuts off the ‘veins’ of the tree and causes the tree to die. The disease appears to only affect beech trees over eight inches in diameter and may not kill all trees that it infects, however trees are ultimately weakened making them susceptible to other stresses. When inspecting beech trees, look for trees that are thinning or yellowing in the upper canopy. Look for tiny (less than 1 mm) wingless scale insects on the bark. After feeding, the scale cover themselves in a white, waxy coating that can be visible on the bark surface. Once the scale insect has created an opening in the bark and the fungus has infected the wound, fruiting bodies can be visible as deep orange-red, oval shaped marks seen on the bark in the late summer and fall. The fruiting bodies may also be identified as an oozing from the bark.

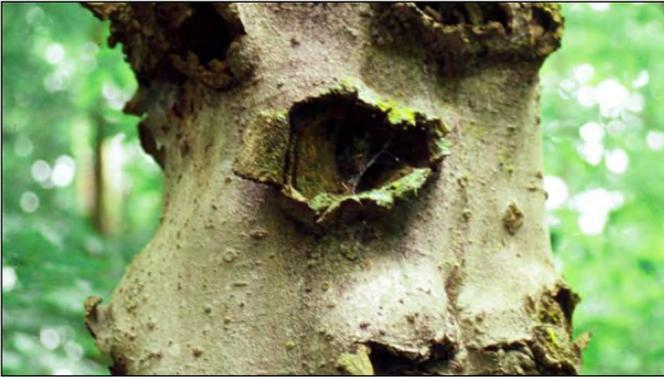
Trunk with Cankers

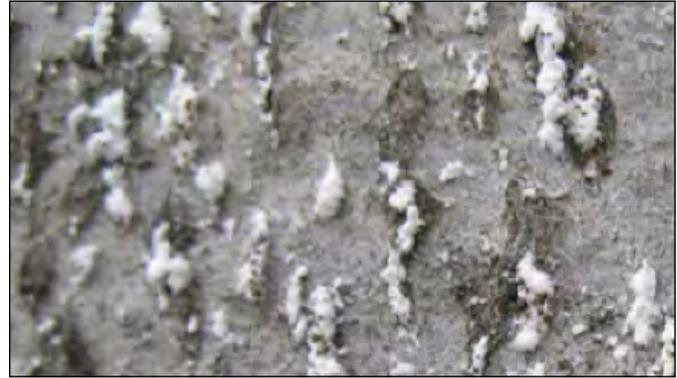
Scale insects with white fuzzy covering

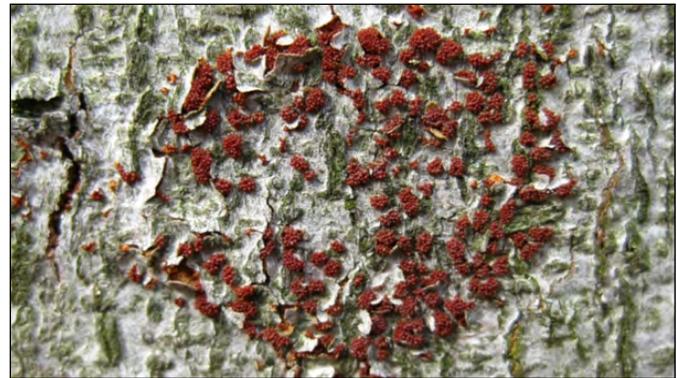
Nectria fungus fruiting bodies

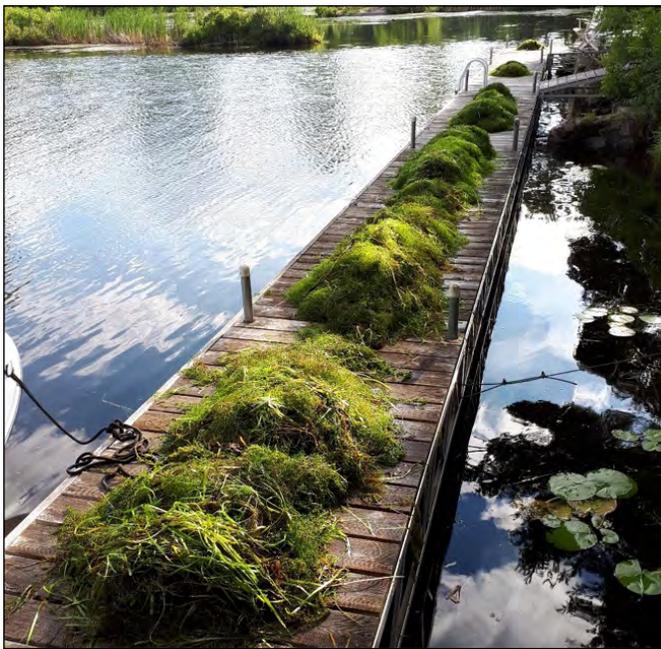
Starry stonewort. After an hour's work with rakes and pitchforks, a narrow swath was cleared from one side of this dock. It barely made a dent in the bay's plant mass.

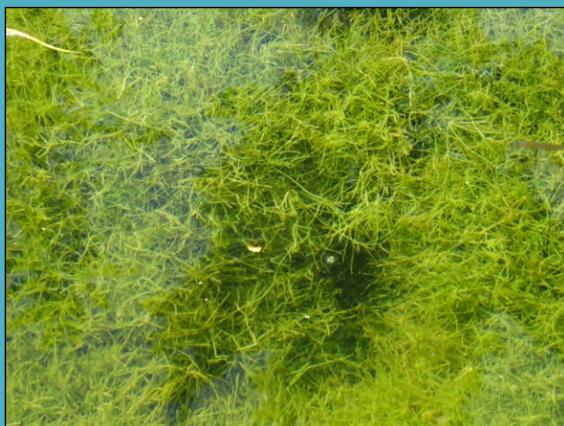
Starry stonewort in the waters of Stony Lake
Photo Carol Cole

Starry stonewort (*Nitellopsis obtusa*) is a green macro algae (family Characeae) native to Europe and Asia. It is spread primarily through fragmentation. It grows in water up to 23 metres deep, carpeting the bottom in dense mats up to about two metres thick. By covering the bottom of the lake it can potentially destroy fish spawning areas. In shallower water, three metres or less, it will grow right up to the surface. Initially you may notice that your shoreline appears to have significantly fewer weeds. This is because once starry stonewort is established, it chokes out native species and other invasive species such as Eurasian milfoil. It becomes so dense it is impossible for fish and other water inhabitants to swim through it.

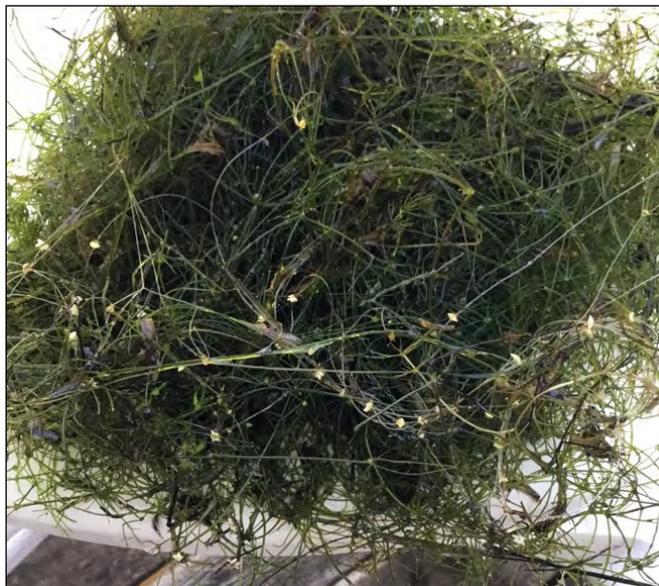
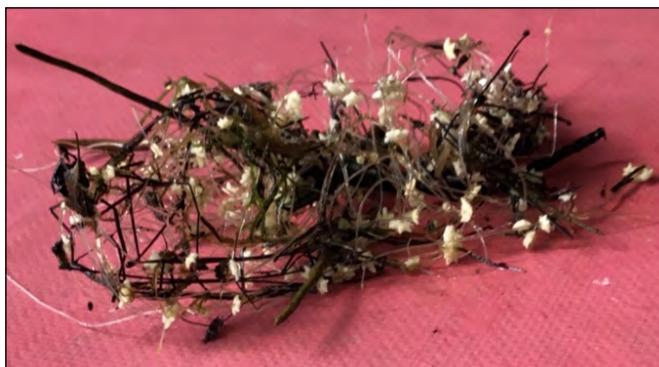
(Above) Starry stonewort, freshly harvested
Photo Patty Macdonald

(Below) Notice the white bulbils on the branches
Photo Patty Macdonald

It is identified by small, white, star shaped bulbils found on the branches of the algae. These small white stars do not die off over the winter. Rather, they will lie dormant and regenerate when waters warm and will create new infestations. It's not a plant or weed as it has no seed or roots.

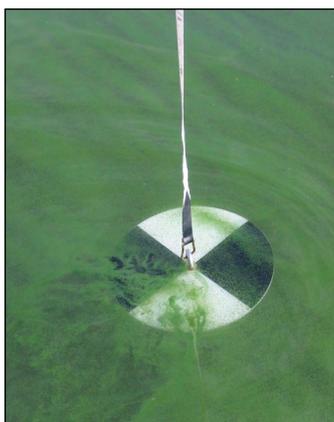
Named after its inventor, Angelo Secchi, a Secchi disk is a device for measuring water clarity. It is a weighted disc 20 cm in diameter with alternate black and white quadrants. When lowered into a lake, the depth at which the disc can no longer be seen (the black and white quadrants cannot be distinguished) is called the Secchi depth. The deeper the Secchi depth, the clearer the water. Basic water clarity can be affected by the amount of sediment or Dissolved Organic Matter (DOM) that the water contains. Seasonal variation of water clarity is usually related to the amount of algae it contains resulting in spring and fall Secchi depths being greater than mid-summer values. The Lake Partner Program (LPP) asks volunteers to measure the Secchi Depth every two weeks between early May to early October but for practical reasons many sites can only be measured in conjunction with phosphorus sample collection, about six times a year.
